AWD DIAGNOSIS

Symptom: AWD Will Not Engage

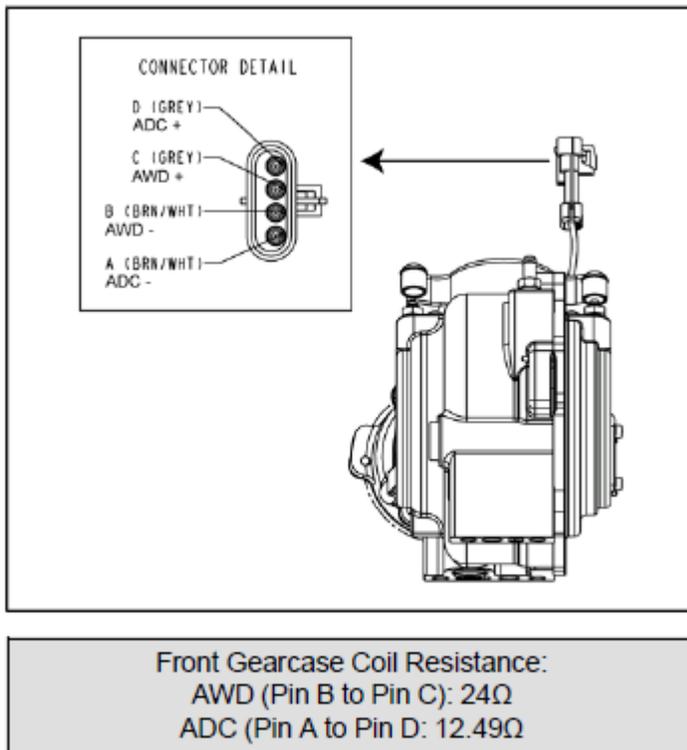
1. Check the gearcase AWD coil resistance. Measure between the Grey (C) and brown/white (B) wires. The resistance value should be within resistance.

2. Turn on the ignition switch and AWD switch and place gear selector in HIGH or LOW gear. Check for minimum battery voltage at the chassis side of the AWD/ADC connector. Measure between the Grey (C) and brown/white (C) chassis wires that power the AWD coil. A minimum of 11 Vdc should be present.
3. If electrical tests are within specifications, remove the front gearcase and inspect the internal parts.

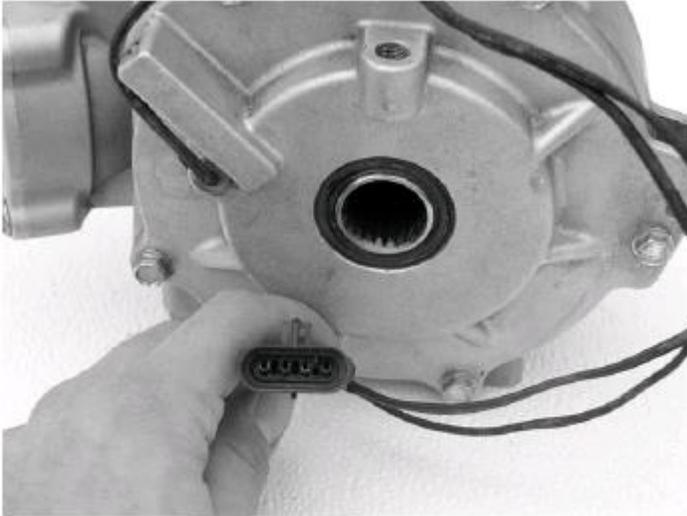
1. Check the gear case coil resistance. To test the gearcase coil resistance, use the coil harness (Grey & Brown/White).
 - **NOTE:** *To test the gearcase coil resistance, use the coil harness. The gearcase coil should measure between 22.8 ohms and 25.2 ohms.*

ADC Front Gearcase Coil Resistance
B-C (4X4): $23 \Omega \pm 4\Omega$
A-D (4X4 ADC): $12.49 \Omega \pm 4\Omega$

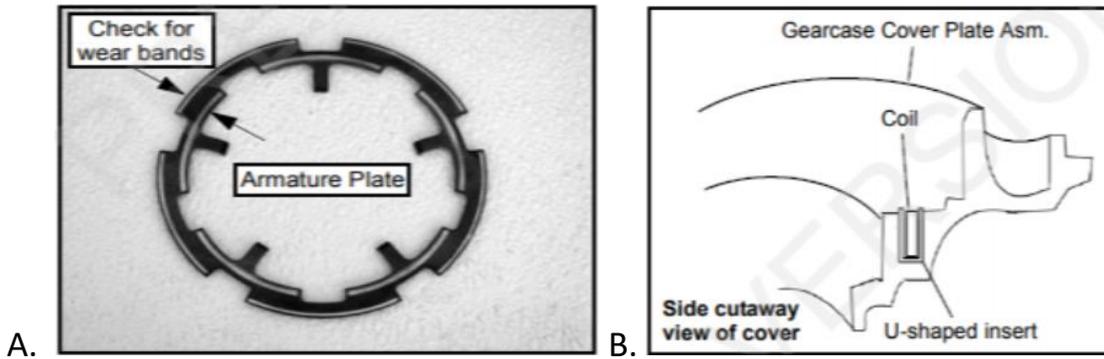
- Inspect armature plate for consistent wear pattern. There should be two distinct wear bands (one band inside the other) as indicated in picture A. If only one band of wear is present (or if there is a wear between the two bands), inspect coil area as indicated in picture B. A wear band with interrupted wear mark may indicate a warped plate, which may cause intermittent operation.

- Check to make sure the coil is seated in the U-shaped insert that is pressed into the gear case cover. The top of the coil should be seated below the U-shaped insert. The U-shaped insert controls the pole gap. If the top of the coil is above the surface of the u-shaped insert it raises the armature plate, thereby increasing pole gap. If the pole gap increases the coil will not be strong enough to engage the AWD system. If this is found, replace the cover plate assembly.
